A Study on Repair Materials for Fire Affected Reinforced Concrete Beams

HANUMANTHU SANDEEP¹ and CH. KAMESWARA RAO²

M.Tech Student in Civil Engineering, Pydah College of Engineering, Visakhapatnam¹

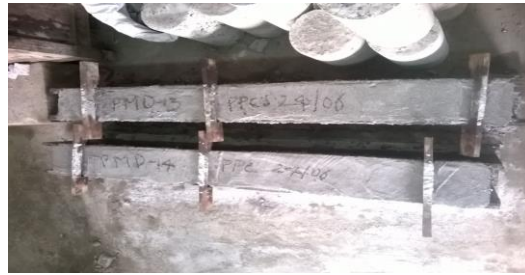
**Fig.1 Beams after casting****Curing of specimens:**

The reinforcement cage is shown in the Fig.1.3. The clear cover provided in the columns is 15 mm and the clear was maintained using cover blocks. Cover blocks were kept inside the beam moulds at the bottom and sides. The reinforcement cage was placed in the mould. The beam moulds were filled with concrete. Each layer was compacted using a needle vibrator. The surface was leveled with trowel and was marked for identification.

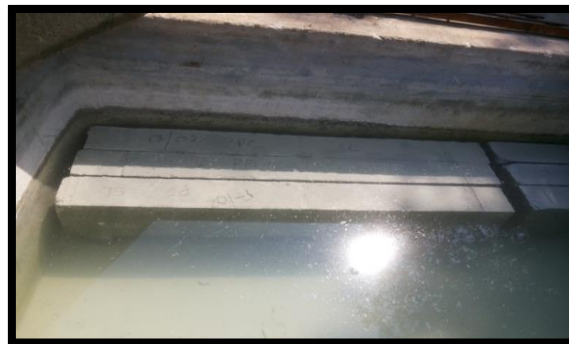
**Fig.1.2 Curing of specimens****Exposing the specimens to higher temperatures:**

The cube and beam specimens were de-mould after 24 hours of casting. The de-mould specimens were cured in a water tank for a period of 28 days (as shown in the Fig.1.5).

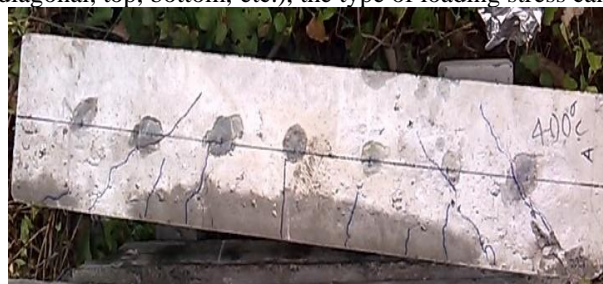
Crack Patterns: Overloading a concrete member may cause several types of cracks. Depending on the direction and location of the crack (vertical, diagonal, top, bottom, etc.), the type of loading stress can be identified.

Fig.2.6 Beam crack pattern at 400°C after repair with repair material 1
