# **An Overview on the Causes and Spatial Pattern of Erosion in Katsina State, Nigeria**

**Abstract:** This paper presents an overview of the major causes of erosion and the spatial pattern of erosion in the Katsina region. The factors that cause erosion are mostly climatic, environmental and anthropogenic. The factors operate together depending on the environmental circumstances and time. Climate, geology, soil character and vegetation or land cover characteristics are the important influences on erosion. The climatic factors that influence runoff and erosion in the Katsina region are precipitation, temperature and wind. Precipitation is obviously, by far, the most important. The entire Katsina region has generally very 'hard' rainfall associated with tropical thunderstorms but differences do exist between the northern and southern parts of the region. In the southern part, around Funtua, Temperature and Rainfall average 24.8 °C and 1024 mm respectively, while in the northern part around Daura, the Temperature and Rainfall average 28.8 °C and 578 mm per annum respectively. Vegetation cover also decreases from north (Sudan Savannah) to south (Guinea Savannah). These might have aff

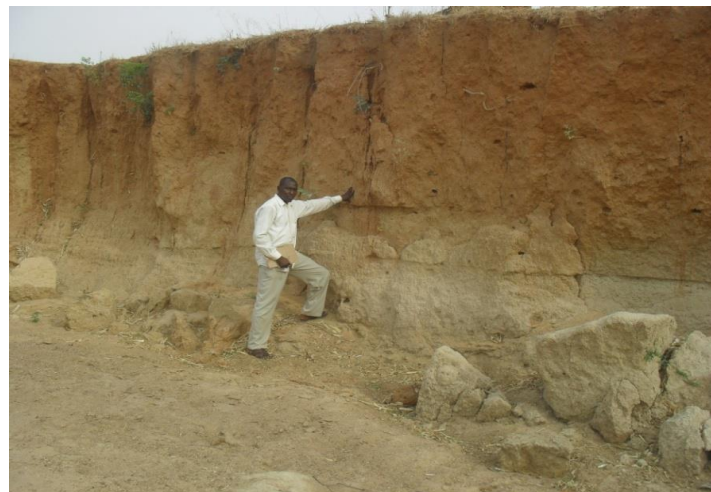
Figure III: (S2) Gully Erosion along at Wakaji along D/ma-Wakaji Road

Table I shows that among the gullies studied in the field, site  $S_2$  at Wakaji is the largest in size as well as in mean depth and width. It appears to be a spectacular u-shaped gully with sides more or less like a cliff with a depth of up to 6 metres. This is followed by site  $S_{10}$  which has 68.6 meters cross section and yet is the widest but very narrow in proportion to the width. The smallest gully in cross sectional area is  $S_3$  with only 4.7 meters square. These characteristics of the gullies are also depicted in figure IV below with a clear inter-relationship between gullies and intra-relationship between average depth and average width in each gully.
