# 2019-FLASHFLOOD IMPACTS OF KAPILA RIVER ON TEMPLE TOWN OF NANJANGUD, KARNATAKA, INDIA

**Abstract:** India is extremely liable to floods and out of the overall region of 329 mha, over 40 mha is flood prone. Floods are recurrent phenomenon, which cause huge loss of lives and damage to livelihood system, loss of domestic animals, property, infrastructure and public utilities. It is a cause for great concern that the increasing trends are noticed to be high in connection with flood damages. This can be attributed to many reasons including rapid increase in population & urbanization coupled with growing developmental and economic activities in the floodplains and global warming. Continuing and large scale loss of lives and damage to public and private property due to floods indicate that it still need to develop an effective response to floods. The present study aims to strengthen the existing criteria for flood preparedness and to minimize the risk analysis in Kapila River floodplains of Nanjangud. Limited field visits are carried out during & after flood impacts and field photographs has been effectively collected. Survey of India (SoI) topomap, IRS-1D, PAN+LISS-III and ASTER G-DEM

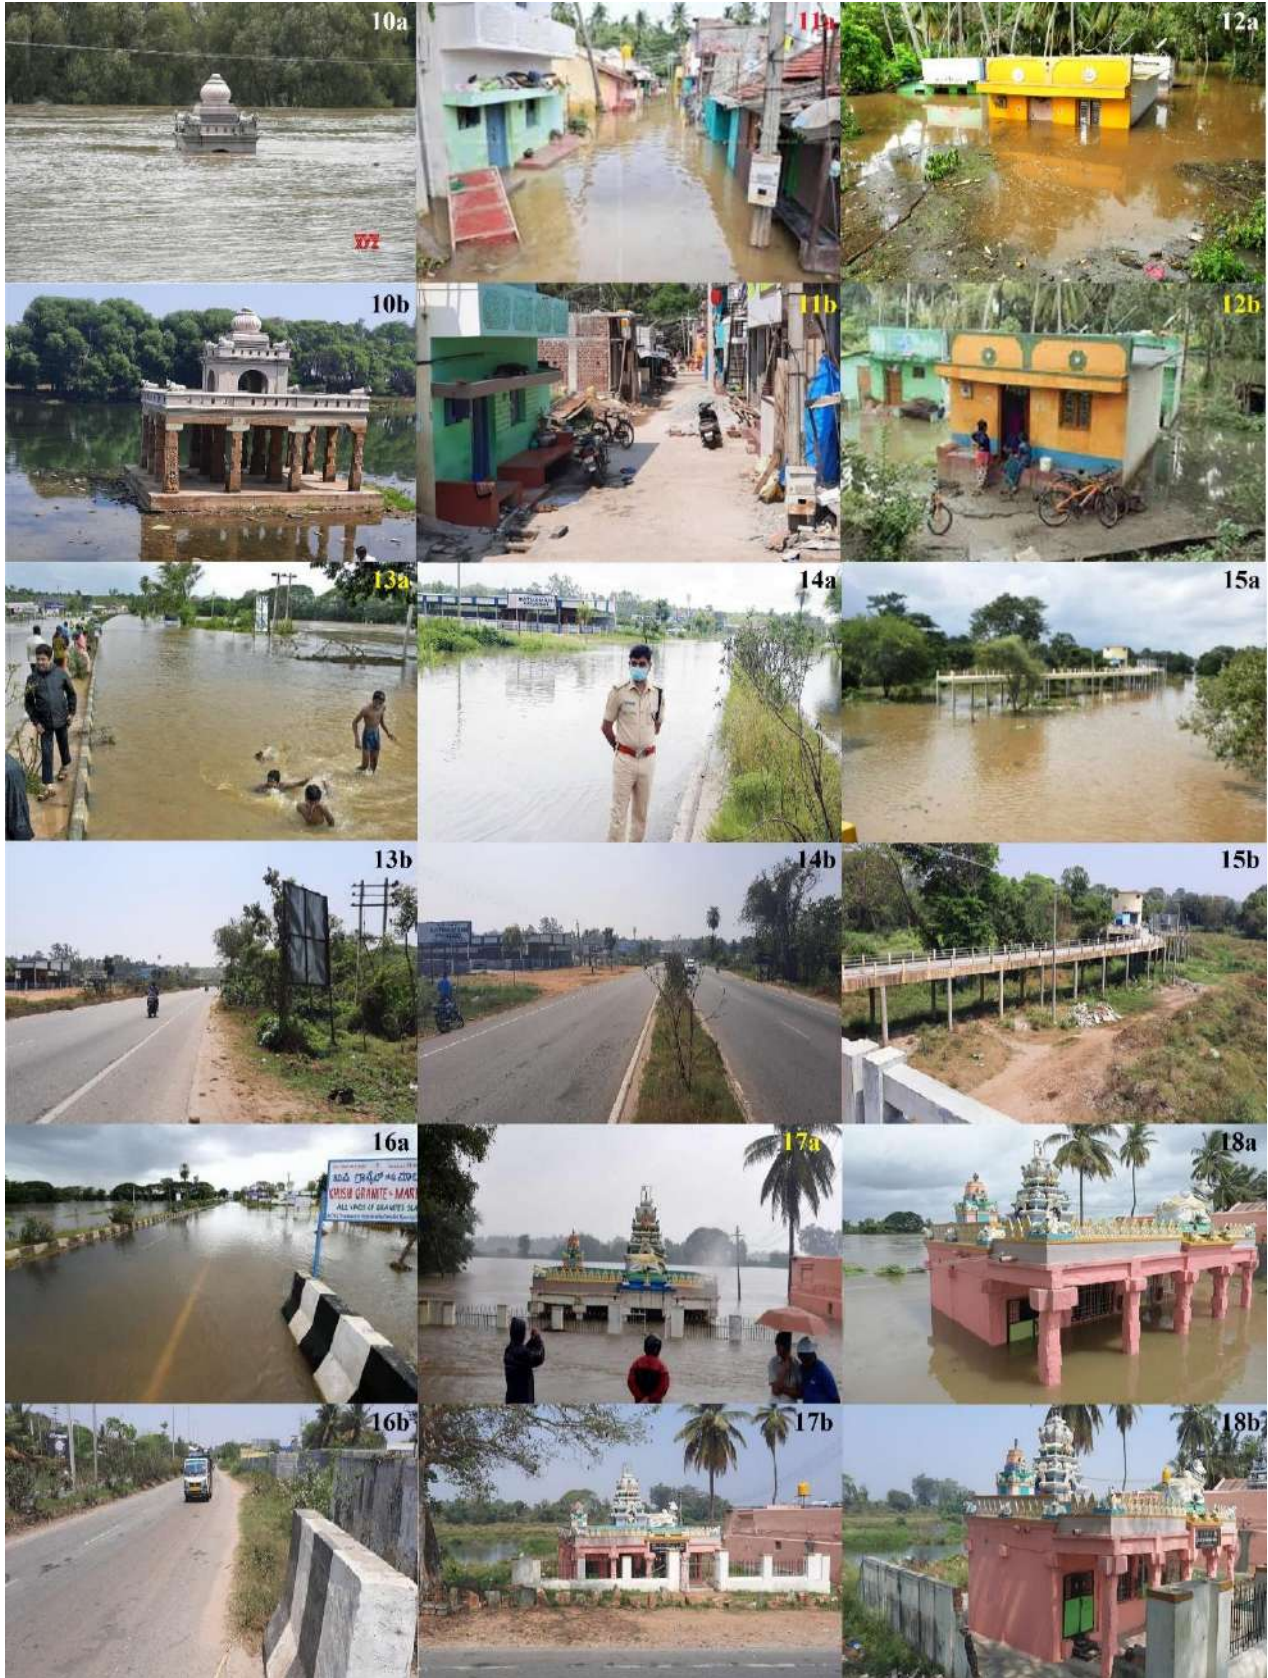
**Plate-II:** (a) During and (b) After the Flashflood impacts of Kapila River on 10. 16 Pillar tomb; 11 & 12. Streets near Main temple; 13. NH-712 near Mallanamoole Mutt; (i) Nanjangud Water works; (k & l) Road block of NH-766 from Mallanamoole Mutt till Mysore Paper Mills Kapila river water submergence (a, b, c d & e) Blocking the road between Mallanamoole Mutt to Mysore Paper Mills on NH-766; (f) Submergence of Parashurama Temple

**3.1 Damage Assessment:** Discharge of 1.25 lakh cusecs of water from the Kabini, Taraka and Nugu reservoirs has inundated the temple town of Nanjangud which resembled an island on Friday (11<sup>th</sup> Aug 2019). The Irrigation Department had assessed the affected areas of flood damage in the taluk. The drone photos clearly captures the areas submerged including the Suttur Mutt in the taluk turning into an island (Plate-I; Plate-II; Plate-III). Most of the prominent temples, including the famous Srikanteshwara temple (Plate-I: 1a; 2a), Ayyappa Temple, Parashuram Temple (Plate-III: 21a), Chamundeshwari Temple, Chikkamma ChikkaDevi Temple were flooded due to high rise in Kapila River as incessant rain occurred in Wayanad district of Kerala state. Meanwhile, a person was killed in house collapse at Veeranahosahalli. Madapura, Bidirahalli and Hommaragalli bridges had submerged in high flowing river water. Water has gushed into houses at Kurubageri, Halladakeri, Gowri Ghatta Beedhi, Chamarajanagar bypass roads are also inundated (Plate-II: 11a & 12a).

The Karnataka-Kerala main road has been blocked as the road at Mallanamule Mutt is marooned (Plate-I: 7a; Plate-II: 17a & 18a; Fig.4). Meanwhile the river is roaring and iconic 16 Kaalu Mantapa (16 Pillar Pavilion) has submerged in the river and only tomb on the top is visible (Plate-I: 3a, 4a; Plate-II: 10a). The water level at the river is touching the stairs of bathing ghat (Snanaghatta and mudikatte) triggering danger (Plate-I: 5a). As a precautionary measure, devotees are restrained from visiting Parashurama temple (Plate-III: 21a). The river level has also touched the Kabini bridge near Basavanapura on Mysuru-Nanjangud (Plate-I: 6a). District administration has alerted villagers in the downstream to take necessary arrangements for safety and warnings had issued against venturing near the river. Most of the areas in Nanjangud have turned into islands due to the overflowing of Kabini River resulted in damages to 379 houses, 3 cattle shed and farmers have suffered crop loss due to flash flooding. Halladakeri, adjacent to Srikanteshwara Temple is flooded and residents have been moved to safety (Plate-II: 11a, 12a). The district administration has opened a several relief centers in the town and shifted peoples safely. Drinking water supply showed the pollution of industrial effluents, agricultural runoff, domestic and municipal sewage contributions (Azadeh and Basavarajappa, 2012).

**3.4 Traffic Diversion:** A stretch of Mysuru-Nanjangud highway, which is part of National Highway 766, that connects Bengaluru with Ooty, remained out of bounds for the third day on 11<sup>th</sup> Aug 2019 (Sunday) with flood water overflowing on the highway (Plate-II: 13a, 14a, 16a). As the NH 766 connects to Tamil Nadu and Kerala, the travelers have been inconvenienced with the traffic being diverted. Due to heavy outflow, several roads were blocked and a few bridges have washed away due to meandering of the Kapila River near Mallanamoole Mutt which widens up in its width (Fig.4 & 5). The road between Mallanamoole Mutt and South India Paper Mill has been blocked and there is over three to four feet of water on the road (Plate-I: 7a, Plate-II: 16a, 17a, 18a).

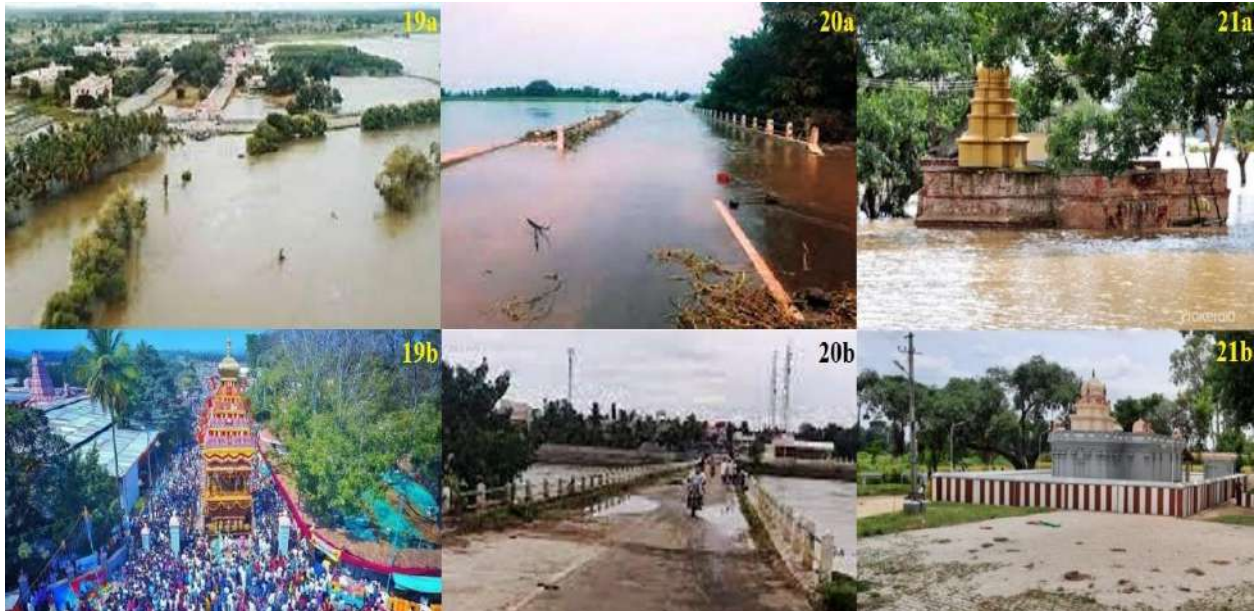
**Plate-III:** (a) During and (b) After the Flashflood impacts of Kapila River on 19. Submergence of Suttur Math turning into an island; 20. Overflowing on bridge connecting between Mysuru-Hosakote and Suttur Math; 21. Submergence of Parashurama temple turning into an island too

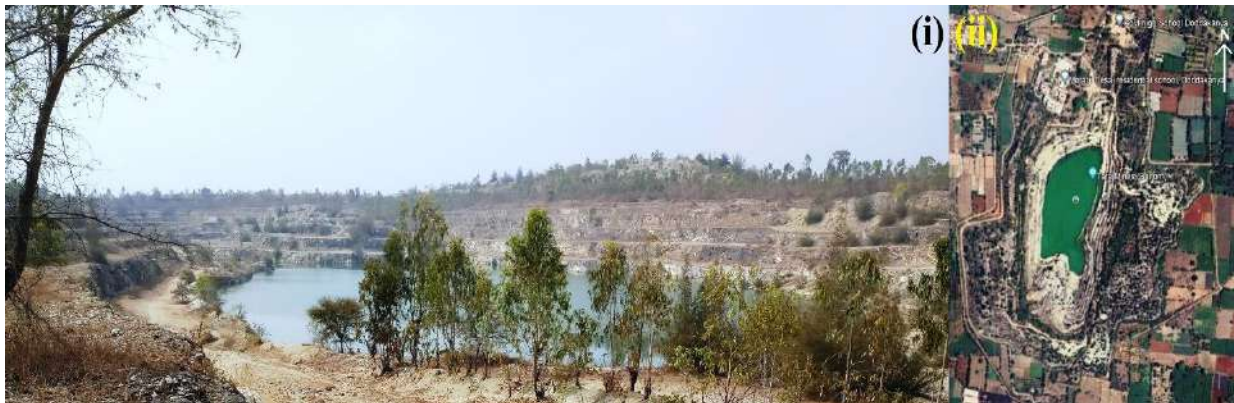
Fig.9 (i) Field photograph and (ii) Google Earth Image of Karya Magnesite Mines, Kadakola town

Floodwater may be diverted to nearby abandoned Karya (Fig.9) and Sindhuvali mining areas from left bank canal of river Kapila during high flow. Construction of percolation tanks, deeper recharge pits/ shafts on nearby identified wastelands (Fig.7) are the cost effective structures that recharge directly to sub-surface through less permeable zones. Mapping of old & abandoned dug, driven and drilled bore well locations need to be mapped along with their slope information (Fig.8) which may play great importance in storm water management. The dug wells penetrating through fractured zones are most preferred to be deepened for further injection of flood water. Growing crops of wheat, paddy and sugarcane which require more water supply on either sides of the Kapila River during monsoon season may be helpful. Increasing the number of nallas and streams on structural lineaments (Fig.6) may help in reducing the flash flood impacts. Proposed traffic diversion route map (Fig.5) may be helpful in better diverting the vehicles with reduced time, cost and distance.
