# Analysis of Common RCC Detailing Errors as per Indian Standards

**Abstract:** Reinforced Cement Concrete (RCC) structures form the backbone of modern construction, yet reinforcement detailing and placement mistakes remain one of the leading causes of structural defects and early deterioration. Literature indicates that errors such as insufficient concrete cover, inadequate lap length, improper bar bending, congestion of reinforcement, and lack of anchorage are frequently observed on construction sites. Studies further highlight that beams and slabs are most critical for reinforcement placement errors, whereas columns are vulnerable to concreting deficiencies. These detailing errors are often the result of poor supervision, limited knowledge of design codes, time–cost pressures, and the reliance on unskilled labor instead of licensed engineers. The consequences include rework, increased maintenance costs, structural cracks, durability issues, and in extreme cases, collapse. By synthesizing findings from previous research, this study underscores the need for strict adherence to IS codes and international standards, quality control measures, and effective site supervision. Furtherm

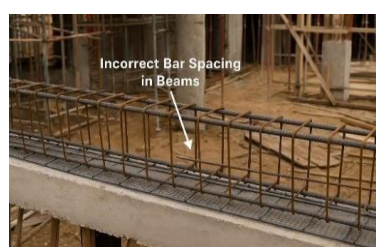
Improper spacing of reinforcement bars often leads to uneven stress distribution and localized cracking within concrete members. Such errors disturb the structural balance and reduce load-carrying efficiency. Along with spacing problems, several execution-related issues also affect construction quality — including early removal of formwork, incorrect concrete mix proportions, lack of site supervision, and dependence on unskilled Labor. Honeycombing or voids in concrete further weaken the section, allowing moisture and corrosion to develop over time. Altogether, these faults significantly compromise the durability, strength, and service life of the structure.

Fig.1 Improper Bar Spacing

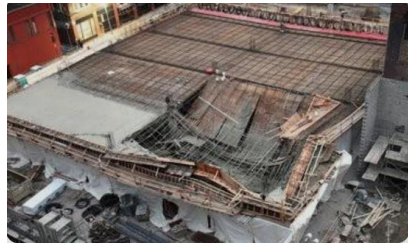
Poor formwork installation, often resulting from inaccurate centering, weak supports, or misalignment, can lead to severe construction defects. When the formwork is not properly aligned or rigid, the concrete may bulge, leak, or set in an uneven shape. These defects not only affect the appearance but also compromise the structural integrity of the member. If the deviations exceed the permissible limits specified in Indian Standards, it may even require partial or complete reconstruction, leading to time and cost overruns. Proper supervision, leveling checks, and timely inspection are essential to avoid such errors.

Fig.3 Formwork failure during slab construction (13)

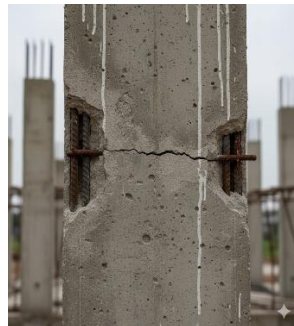
Finishing errors usually occur when the concrete surface is overworked or when extra water is used during trowelling. These actions make the top layer weak and porous, allowing moisture and chemicals to enter easily. With time, this leads to problems like surface scaling or spalling, reducing the overall durability of concrete. To avoid such issues, it is important to finish the surface at the right time, use controlled water, and ensure skilled workmanship.

Fig. 3. Finishing defects in RCC.

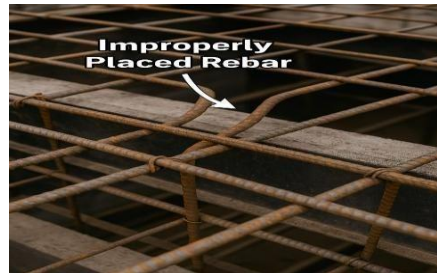
Improper placement of reinforcement is one of the most common and serious issues seen on construction sites. When bars are not tied properly or when chair bars are missing, the reinforcement can shift during concreting, reducing the effective cover. This allows moisture to reach the steel, leading to faster corrosion. Incorrect bar positioning also affects the designed load transfer, reducing

both the strength and serviceability of the structure. Maintaining correct bar alignment, proper tying, and using suitable spacers or chairs during concreting are essential to ensure structural safety and long-term durability.

Fig.5 Poor Reinforcement Placement

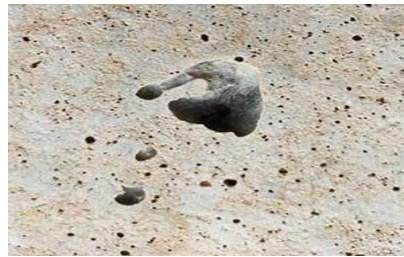
Bug holes are small air pockets or cavities that often appear on the concrete surface, especially along vertical faces. They usually form because of insufficient vibration or poor consolidation during concreting. These air voids not only spoil the surface appearance but also suggest improper compaction, which can reduce the surface durability. Proper vibration, correct mix proportioning, and the use of smooth, clean formwork surfaces can help minimize bug holes and improve the overall finish quality of the concrete.

Fig .6 Bug Holes (10)
