# Assessment of Water Quality near Vicinity of Lignite mine region, Gujarat, India: A case study

S.K. Srivastav<sup>1</sup>, H.L. Yadav<sup>2</sup>, V. Seervi<sup>3</sup>, A.Jamal<sup>4</sup>

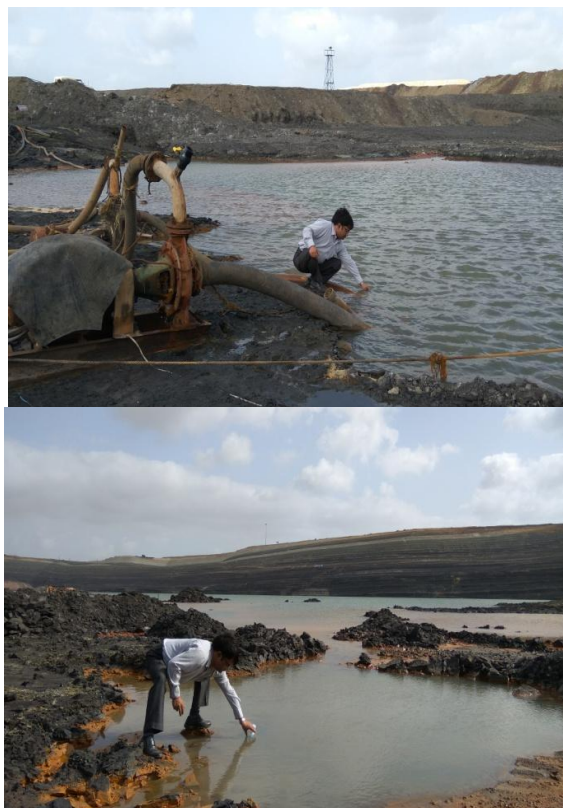
Photograph 1. Water sampling from sump of lignite mine

Photograph 1 and 2 show water sampling operation from mine sump and river passing through the study area. The photograph 3 and 4 show collection of water samples from village dug well pond and pond in nearby villages.

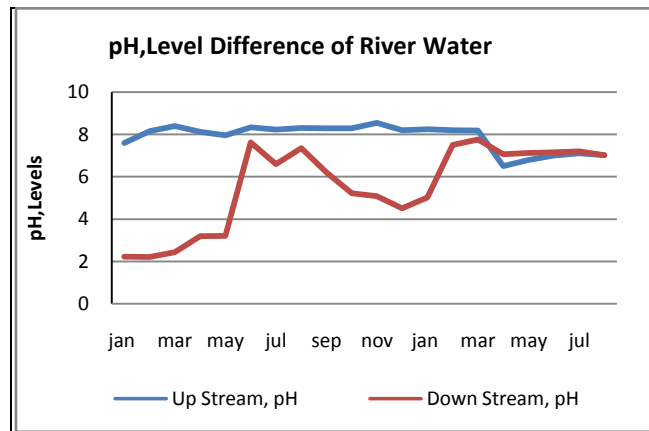
Figure 3. pH Level Graph

The impact of mining on rivers is shown in figure 3. It may be observed from this figure that when there is no river water only mine water flows, the pH of water is near 2.0 with wide fluctuation. However in rainy season the pH value is above 6.0.

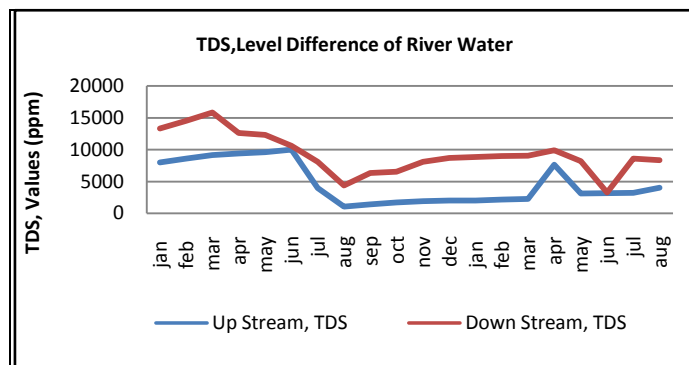
Figure 4. TDS Level Difference Graph

The figure 4 shows the impact of mining on Korawadi river with special reference to total dissolved solids. It may be observed that the TDS value is vary high from January to May (above 10000 ppm) in down stream. Whereas in upstream the concentration of TDS is fluctuating from month to month. The variation may be due to climatic condition fluctuation in the area.
