# Cracks in Pavement Quality Concrete (PQC) - Causes and Remedies

**Ashok Kumar Sharma**

M. Tech (Structure), Technical Adviser, Lion Group, Bhopal, India

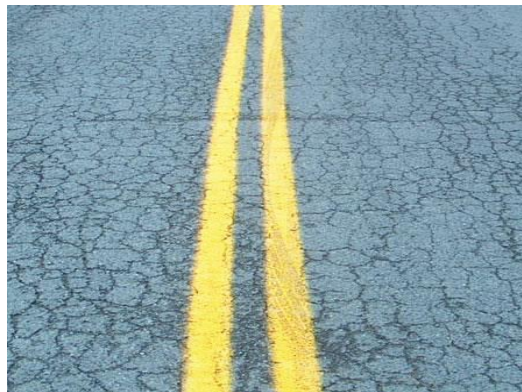
Fatigue failure of concrete roads is the phenomenon by virtue of which the pavement fails under repetitive loading by a load smaller than the load that can cause failure in single application. Larger the load, smaller will be the number of repetition to cause fatigue damage. According to studies, number of factors contribute to the fatigue damage of the pavement, which include heat of hydration, low thermal conductivity, shrinkage and creep. The micro cracks formed at the early age of concrete and the micro-voids formed due to excess water capillary cavities progressively extend under the effect of repetitive loading when the ratio of tensile stress in the pavement and modulus of rupture of pavement material exceeds 0.45. Fatigue failure initiates by weakening the bond between aggregate cement paste within the tension zone till the first continuous cracks start forming from inwards from the tension face which ultimately results in reduction of effective slab thickness and progressive shift in the neutral axis, after which full depth cracks appear, dividing the pavement slab into discrete smaller segments, as shown in fig.-1.

Figure -1 Flexural fatigue cracks

Proper and uniform thickness throughout the length of pavement and high modulus of rupture can assure fatigue adequacy of concrete pavements. Further, the micro cracks which have potential to develop into full depth fatigue cracks can be controlled by low heat of hydration for which the use of blended cements is a viable option. But once the fatigue cracks develop the rehabilitation is inevitable which may go to the extent of full-depth repair.

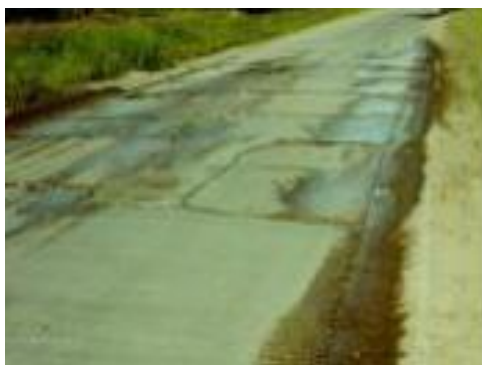
Pumping is the phenomenon of ejection of water and subgrade (or base) material through the joints and cracks or at the pavement edge due to deflection of pavement slab, when the free water accumulates underneath the slab.

Figure 2 Pumping in rigid pavement

Pumping is the feature of rigid pavements only because flexible pavements do not create void space under them, as their rebound capability is not sufficient to do so. Hence flexible pavements fail by rutting, shoving and so on when they are overloaded. Pavement at fills and cut areas are more prone to pumping after rainfall. Pumping takes place after certain duration of time when the pavement is incessantly subjected to heavy vehicular loads. Creation of void space under the pavement where free water accumulates is the primary cause of pumping of subgrade soil. Plastic deformation of soil and warping of the slab due to temperature gradient within slab are factors that promote the creation of void space. The entry of the water in the void space may be due to surface infiltration at the joints and edges of the pavement. The ground water is also a potential source. If the soil is not free draining the water comes out of the pavement when it deflects. The ejection of water is more pronounced at the pavement edge just ahead of joint or crack. After continuous pumping of water and soil, the structural support to the slab reduces which can lead to corner breaking, linear cracking and faulting.

The repair of the pavement which is affected by pumping starts with full depth repair of the affected slab, followed by use of load transfer device (dowel bar) for effective load transfer across transverse joints created after repair. Stabilizing of slabs adjacent to the pumping area is equally important as loss of subgrade base or subbase material would have taken place after pumping. The problems of permeability of pavement and poor drainage of soil should also be addressed.

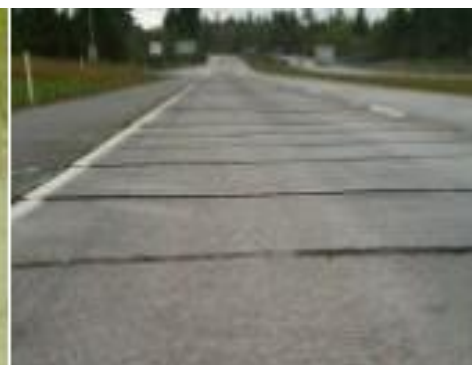
Figure 3 Faulting in rigid pavement

Vertical differential movement of slab adjacent to joint or crack is called faulting. Faulting may be longitudinal or transverse. It is usually seen in case of pavements without load transfer devices. The primary cause of faulting is slab pumping. The other possible causes are thermal and moisture stresses. In the most common faulting mechanism, the approach slab is higher than the leave slab due to pumping.

Faulting becomes noticeable if its average value reaches 2.5 mm. The major problem of the faulting is roughness and unevenness in the pavement which affect the riding quality. Diamond grinding is usually done to restore the pavement if the average faulting reaches 4 mm. Diamond grinding is nothing but removal of thin top layer of hardened PQC (4 to 6 mm) by means of closely spaced diamond saw blades so as to improve the pavement rideability. Dowel bar retrofitting is usually required if the faulting is between 4 and 12.5 mm and if the faulting exceeds 12.5 mm complete reconstruction of the slab (full-depth repair) is necessary.

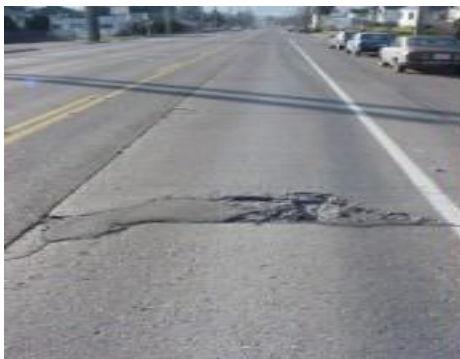
Cracking, breaking or chipping of the edges of cracks, joints and edges of the pavement, is termed as spalling. Joint spalling is usually noticed within 300 mm from the face of longitudinal or transverse joints. Corner spalling is the breakdown of the corners of the slab which is noticed within about 300 mm from the corner. Loose debris on the pavement and roughness are the problems associated with spalling. If spalling is left unattended it may severely impair the serviceability of the pavement.

Figure 4 Spalling

Possible causes of spalling are excessive stresses at joints, cracks and edges, caused by infiltration of incompressible materials and consequent expansion. "D" cracking (durability cracking) or freeze-thaw damage, weakness of pavement concrete at joints or edges due to poor workmanship, improper insertion, misalignment and corrosion of dowel bar and heavy traffic are other causes that promote spalling. Spalling is basically categorized as shallow spalling (occurs within  $\frac{1}{3}^{\text{rd}}$  of slab thickness) and deep spalling (extends at least up to half slab thickness). Partial-depth and full-depth repairs are the remedies for shallow and deep spalling respectively.

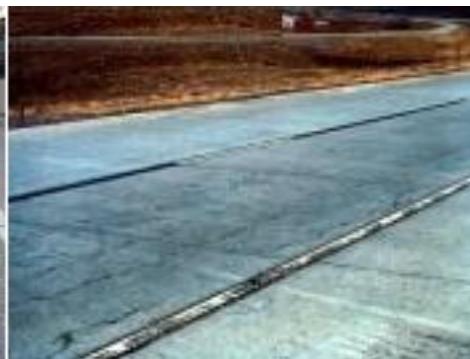
Figure 5 Shrinkage cracks

Formation of hairline cracks during setting and hardening of pavement concrete at places away from the joints are called shrinkage cracks. Shrinkage cracks are not found to extend throughout the slab thickness. Formation of plastic shrinkage cracks is seen in pavements as early as 3 to 4 hours after the pavement slab is laid, they can have width of 0.1 to 3 mm and length of up to 1000 mm. Shrinkage cracks exhibit the uncontrolled nature of slab shrinkage. These cracks allow moisture and chemical movement in the pavement that the pavement surface experience, which is detrimental to the pavement concrete if left unchecked. Severity of damage depends on the width and orientation of crack. The possible causes of shrinkage cracks are, late sawing of contraction joint, poor design of reinforcement, improper curing where the surface of the slab is allowed to dry quickly and use of high early-strength cement or admixtures that give high heat of hydration. Shrinkage cracks can be treated by means of crack sealants if they are of moderate size. Crack sealing procedure is nothing but placement of specialized material into cracks to prevent movement of water into the body of pavement. Synthetic resin is generally used as crack sealant. Entire slab replacement (full-depth repair) is warranted in severe situations.

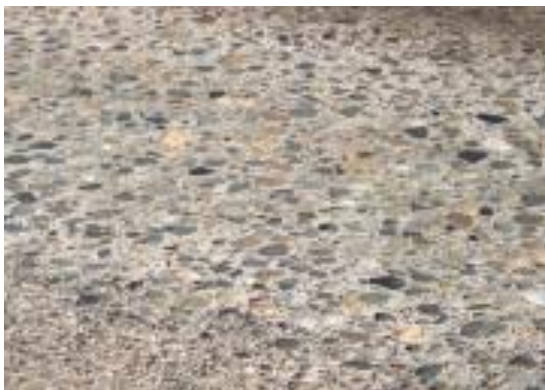
Aggregates which protrude out of cement paste with less angularity and roughness are said to be polished aggregates. In due course of time when the pavement ages due to repeated traffic loads, the protruding rough and angular particles get polished and this can occur if the abrasion value of particles is low. Excessive studded tyre wear also contributes to polishing of aggregates. The obvious problem of polished aggregates in pavement is the reduction of skid resistance, which may lead to riding discomfort and if the severity increases it may lead to road accidents.

Figure 6 Polished aggregates

Diamond grinding or an overlay is the solution to the problem of polished aggregates in rigid pavements.

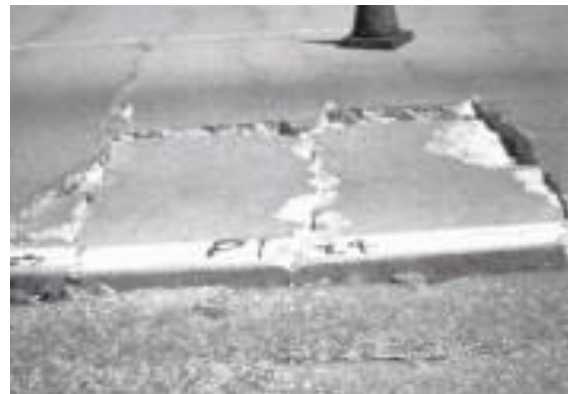
Figure 7 Punch-out

Punch-out is nothing but breaking of small portion of concrete slab into several pieces. It is localized behaviour in concrete slab. Punch-out causes roughness of the pavement surface and creates ingress to moisture into pavement and later in base and subgrade, leading to erosion of base or subgrade. Punching makes cracks to spall and disintegrates them.

Localized construction defect such as improper compaction is the primary cause of punch-out in plan cement concrete pavements. Corrosion and inadequacy of steel are the key factors for the punch-out failure in continuously reinforced pavements. Excessive width and closeness of shrinkage cracks too promote punch-out. Punch-out problems are addressed by full-depth patch.

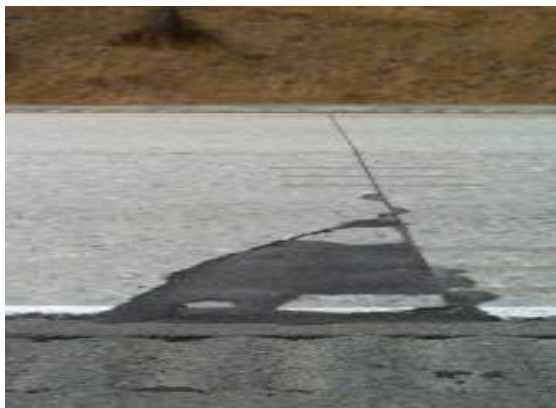
Figure 8 Failure of Joint load Transfer system

Failure of load transfer system at joints is characterized by transverse crack or corner break. The possible reasons for this type of failure are corrosion and misalignment of dowel bars. The products of corrosion which occupy certain volume will induce tensile stresses around the dowel bar and the excess corrosion weakens the dowel bar which may prematurely fail due to repeated loading. Bending of dowel bar and their closeness to the slab edge will induce localized stresses which may be high enough to break the pavement.

Usually the pavement is restored by a full-depth patch at the affected area after replacement of the failed joint load transfer system.

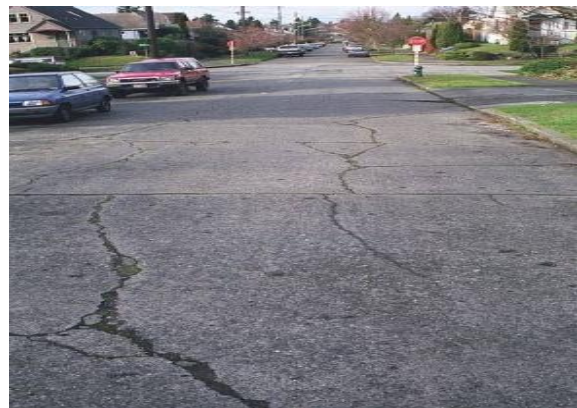
Figure 9 Linear cracking

Linear cracks divide the individual slabs into more than two parts and extend across the entire slab. The phenomenon of linear cracking is also referred to as panel cracking. Linear cracking will affect the riding quality of the pavement. Linear cracking will allow moisture movement in the body of pavement, as a result of which erosion of base or subbase may take place, which may lead to loss of soil support to the pavement. If not sealed the cracks may spall and disintegrate. The possible causes of linear cracking are heavy traffic, temperature gradient, curling of slabs, moisture stresses and loss of soil support. Crack sealant can be used to seal linear cracking. If linear cracking leads to panel cracking, then the pavement is restored by full-depth repair.

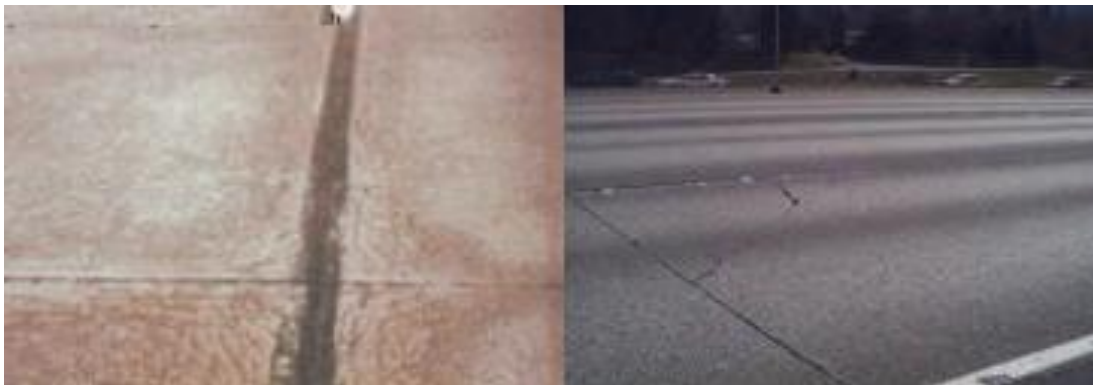
Durability cracking ("D" cracking) is characterized by sequence of crescent-shaped closely spaced hairline cracking pattern. "D" cracking occurs adjacent to joints, cracks or free edges and it normally starts from slab corners. Cracking pattern is characterized by dark colouring of the affected and surrounded area. Aggregates that are susceptible to freeze-thaw are responsible for "D" cracking and due to which roughness of pavement surface, spalling and eventual disintegration of pavement may take place "D" cracking is the problem of aggregates which are susceptible to freeze-thaw damage. The affected pavement can be refurbished by partial-depth or full-depth repair, depending on the severity of the damage but the problem may persist if the aggregates remain vulnerable to freeze-thaw attack.

Figure 10 "D" cracking

Figure 11 Corner break

A crack that intersects the joint of the pavement near the corner of the slab (within 200 mm) is called corner break or corner crack. It can extend through the entire slab. The causes that are responsible for corner break are high corner stresses, loss of soil support, curling and warping stresses and ineffective load transfer at the joints. Corner break leads to infiltration of moisture, faulting, spalling and disintegration in the pavement slab. Full-depth repair is the solution to refurbish the pavement that suffers corner break.

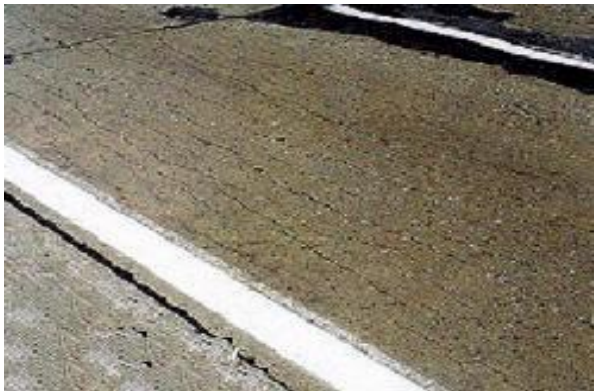
In hardened concrete, aggregates containing reactive silica interact with alkali (sodium oxide and potassium oxide) present in the cement to form expansive alkali silicate gels which disrupt the concrete by forming pattern cracks.

This phenomenon is popularly known as alkali-aggregate reaction. Factors that promote this reaction are reactive aggregates (high silica content), high alkali content in cement (more than 0.6 per cent), moisture and conducive temperature (10 °C to 38°C) conditions.

Figure 12 Alkali-aggregate reaction

Factors that promote alkali-aggregate reactions need to be controlled to keep the pavement away from this menace. Hence use of non-reactive aggregates, low alkali cement and pozzolanas can help in this regard. Controlling temperature and moisture conditions is also very helpful. It has been observed that osmotic pressure which develops on the set cement gel due to alkali-aggregate reaction is responsible for disruption in concrete. Use of air-entraining agents is found to be useful in absorbing osmotic pressure. The alkali-aggregate reaction if unchecked may cause other problems like pop-outs, spalling etc. and concrete slab may require partial-depth or full-depth repair depending on severity.

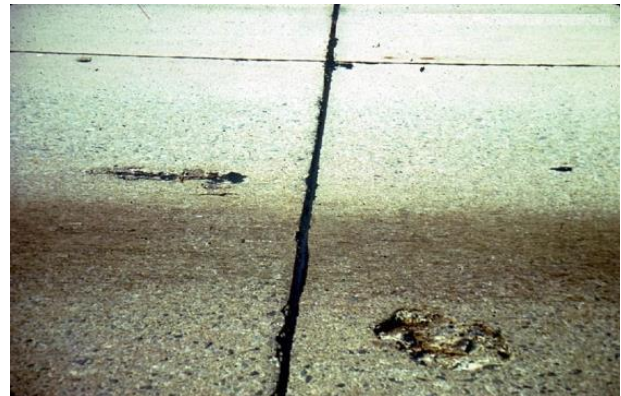
Figure 13 Pop-outs

A small piece of concrete that breaks loose from the surface of pavement concrete, either due to expansive nature of aggregate or due to low quality of material and workmanship, is known as pop-out. 25 to 100 mm in diameter and 13 to 50 mm in depth are the usual sizes of pop-outs. Pop-outs cause discomfort to riding and are not repaired unless they pose threat to tyres of vehicles. Pop-outs of greater size need to be repaired by partial-depth repair.

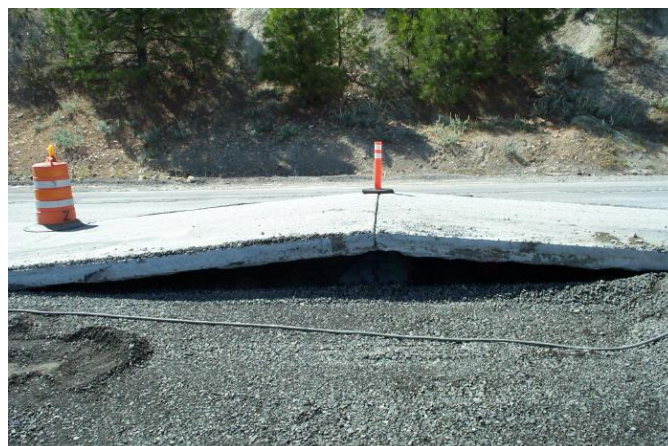
Localized upward movement or shattering of the pavement slab due to increasing compressive stress at the joints or cracks is called blow-ups. During winter wide joint openings are created due contraction of concrete slabs. These joint openings are usually filled by materials like rocks or soil which are incompressible. During summer the expansion of joints is prevented by non-availability of space (occupied by incompressible material) and hence compressive stresses are induced at the joints, which may cause the slabs to shatter or move upward. Hence the blow-up is the consequence of compressive joint failure.

Figure 14 Blow-up

Spalling of the joints, “D” cracking and freeze-thaw damage will hasten the process of formation of blow-ups. Full-depth repair is the only alternative to rehabilitate the pavements which suffer damage due to blow-ups.

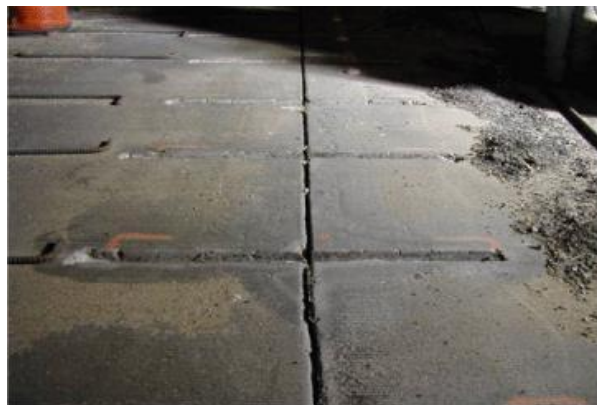
Figure 15 Slots and U-bars

In U-bar stitching, slots are cut using a slot cutting machine and concrete is broken and removed by pneumatic hammer. In this method, anchoring action by the U-bars provides most of the restraining force. Proper backfilling around the ends of the U- bars is important.

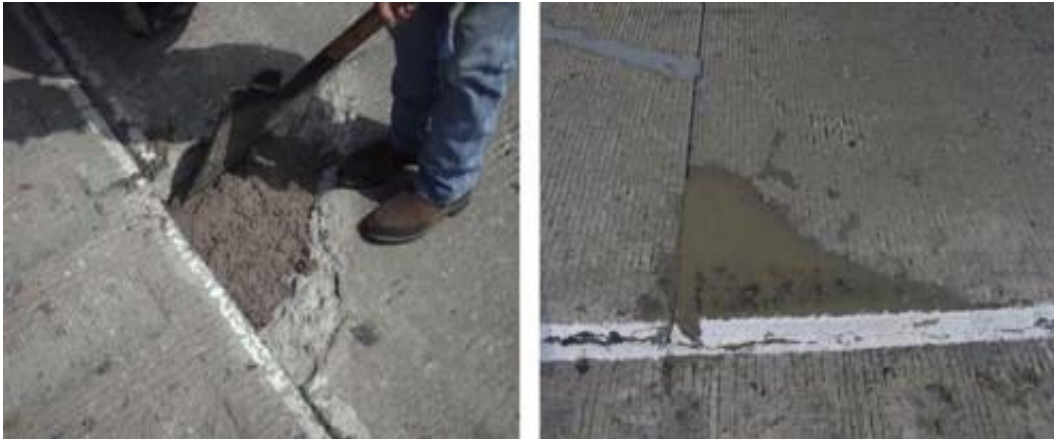
This method is used to correct several distresses which are mentioned in section. Identification of deteriorated concrete, demarcation of repair boundaries, removal of distressed concrete, cleaning, joint preparation, application of bonding agent, placing the patching material, texturing, curing and joint sealing are the sequential operations before the pavement is opened to traffic. Cementitious grout is usually used as bonding agent. The patch mixture should have strength of the concrete of the existing pavement. The repaired patch is often cured by a curing compound which should be applied as soon as possible to avoid occurrence of shrinkage cracks. If properly done the partial depth repairs can perform well for 3 to 10 years [11].

Figure 16 Patch repair

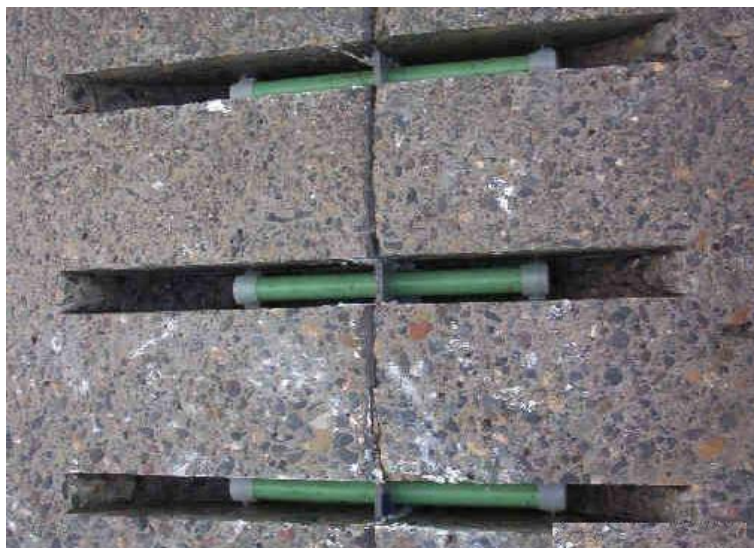
This rehabilitation technique is applicable to only jointed concrete pavements. Low load transfer efficiency (less than 60 per cent), greater faulting and differential deflection of pavement slab are the reasons for dowel bar retrofitting. Slots of required size are cut using diamond saw slot cutters. Dowel bars are then placed in the prepared slots and then the slots are back filled. Backfill materials should have similar thermal properties to the concrete, provide strong bond to the existing concrete, be fast setting, have little shrinkage, and develop enough strength to allow traffic in a short time. High early strength concrete is used for this purpose. High early strength concrete usually contains ASTM Type III cement, accelerators, and aluminium powder. Accelerators and aluminium powder improve set times and reduce shrinkage. Aggregates in the mix should be small enough to allow the concrete to flow around the bar and consolidate properly. Consolidation of backfill material is done with a small spud vibrator. Care should be taken not to hit the dowels with the vibrator, since touching dowels with a vibrator will knock it out of alignment. Once the backfill material is applied, the surface is finished flush with the surrounding surface. Curing compound should be applied as soon as practical.

Figure 17 Dowel bar retrofitting
